Asset Management Committee

**Minutes of the meeting held on 1st October 2019
at 5:00pm at the Council Offices, Market Street, Carnforth**

Heating Appraisal Report

Condition Report, November 2019

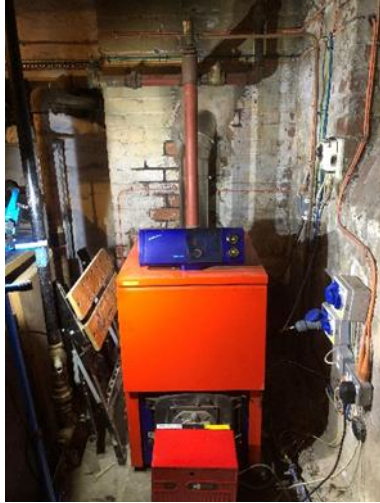
- I. The existing oil-fired boiler is 22 years old and approaching the end of its economic life expectancy of 25yrs. (20yrs for the pressure jet burner). There are ongoing maintenance issues with the boiler and external oil tank, with regular failures and incurring costly call-out maintenance charges.

The existing heating system is fed by an oil-fired boiler located in the basement storeroom at the rear of the property. An external GRP oil storage tank is located at ground level at the North West end of the building. The boiler is a SIME model IR7 fitted with a Reillo forced draught burner rated at 54-120kW. The boiler is rated at 78kW and was installed in 1997. The boiler and burner are towards the end of their economic life expectancy in accordance with data published by the Chartered Institution of Building services Engineers (CIBSE). This is further evidenced by frequent boiler failure. The boiler plant is located in a room containing flammable materials and in the opinion of the author presents a fire risk.

1. Existing oil boiler

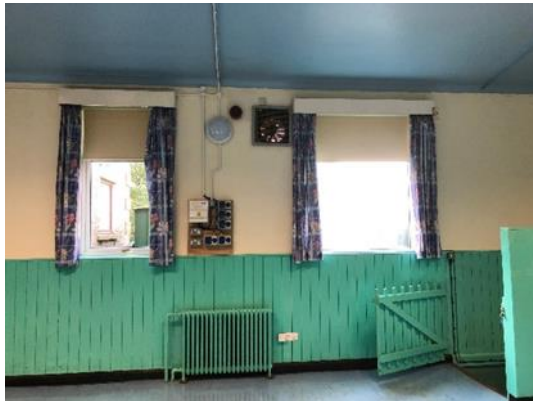
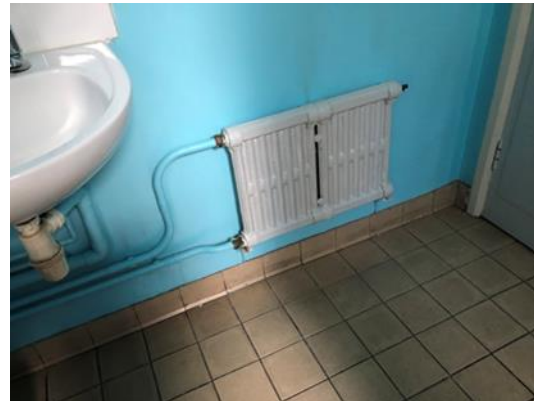
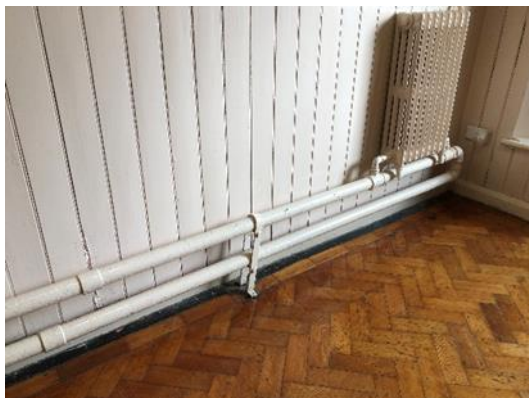
The pipework distribution is generally via a basement area on the West side and within floor ducts and exposed on the East side. The pipework serves cast iron radiators and steel panel radiators. Large bore pipework is exposed in some rooms which provides additional useful heating output. Judging by the size of the radiators relative to room dimensions, the system was designed to provide background heating only which was typical of the period. The pipework and radiators are aged and long overdue replacement.

4. Typical existing radiators

- IV. New zoned heating distribution pipework is installed to serve the Toilets/Kitchen, Hall and Meeting room. Contemporary vertical panel style radiators with thermostatic valves and zone control valves are installed with primary pipework distribution at high level in the corridors.
- V. The installation of solar photovoltaic panels on the South West roof pitches should be considered together with hot water PV optimisation to a new replacement hot water cylinder in the Disabled toilet.

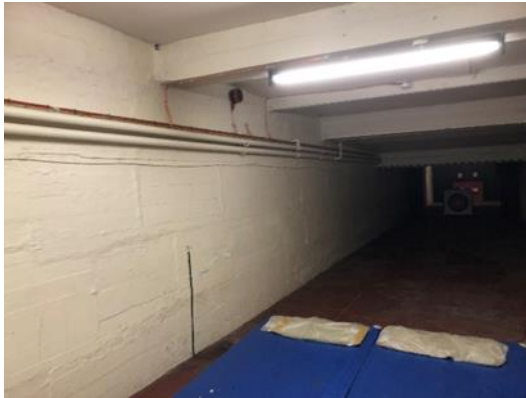
5. Heating distribution pipework through basement

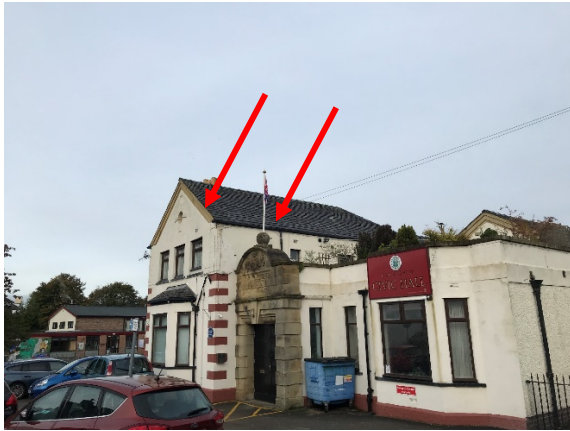
Condition of the roof covering of the east slopes is reasonable with just one slipped slate observed at the front gable and one slipped slate at the eaves above the flat roof. These should be re-fixed.

East roof slope of two-storey wing indicating location of 2no. slipped slates

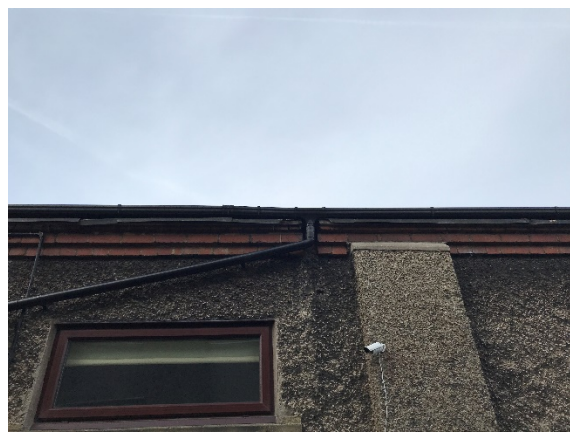
The drill hall has UPVC gutters on the east side that discharge to UPVC circular downpipes. Where the original gutters have been removed, a timber batten covered with mineral felt has been introduced to attempt to cap the wall head, however in places where the felt is missing (natural degradation) the timber batten has started to decay.

Decayed timber batten below the gutter line on the east elevation of the drill hall where the mineral felt covering has degraded.

On the east elevation of the drill house, replace any decayed sections of the timber batten at the wall head along with the mineral felt covering. B3

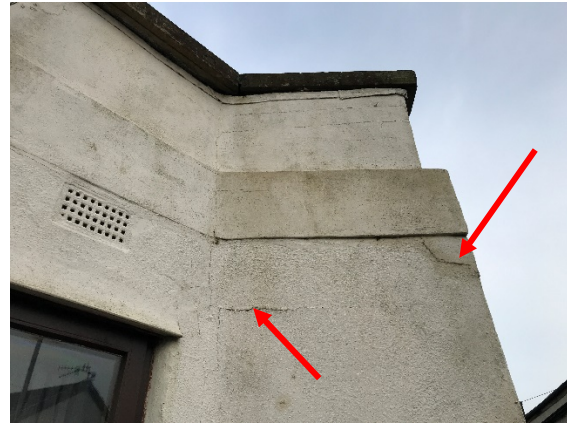
The south elevation of the flat roof section has flat coping stones set on a lead DPC. The wall is covered in smooth render and fine cracking was observed in several places most notably the upper right side on the parapet and at the base of the right mullion on the bay window. Crack lines are generally horizontal, perhaps following brick coursing, as well as vertically at changes of direction in the wall plane i.e. at the junction with the diagonal projection of the bay. These cracks should be capable of repair prior to redecoration of the façade. The paint on the wall is failing, allowing water penetration behind. If left unchecked, this could rapidly lead to damp issues as water gets in behind the paint and is unable to escape, causing damage to the render and possibly the brickwork walls. Redecoration of all painted surfaces is recommended using an appropriate paint system such as Keim Mineral Paint, applied to a site-specific specification drawn up in collaboration with the paint manufacturer.

Fine cracking in the render and paint system on the façade of the drill hall.

Repair the fine cracking in the render on the south façade (North Road) and redecorate using Keim Mineral Paint or similar, to a site-specific specification written in collaboration with the paint system manufacturer. C1

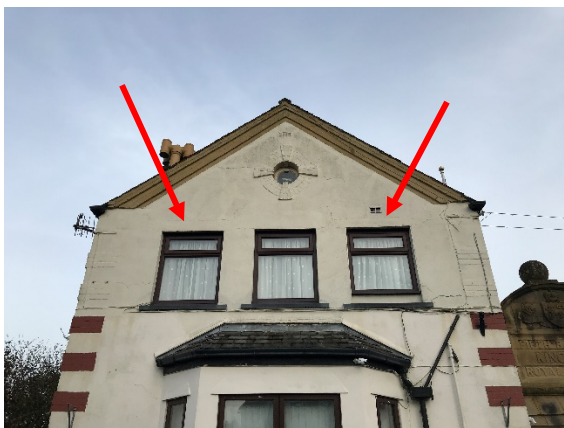
This approach should be adopted for the south façade of the two-storey wing also where the phenomenon of fine cracking was also observed, with most cracks at first floor level.

Cracking also observed in paint/render on first floor of the accommodation wing, above and adjacent to the window openings.

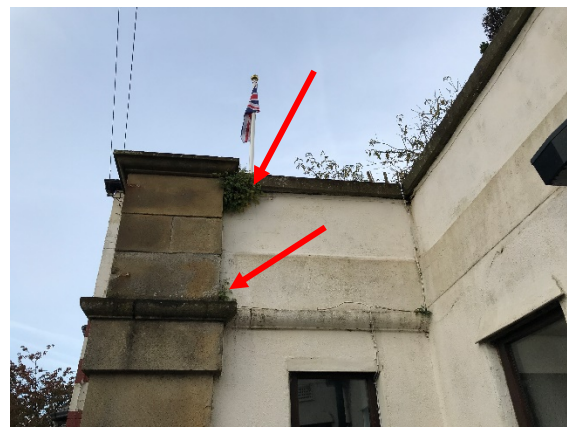
In places on the south façade, small plants were observed growing from masonry joints, such as those on the east side of the entrance porch. The plant growth is an indicator of moisture presence in the masonry and most likely damaged masonry joints. The plants should be removed prior to the joints being raked out and re-pointed.

Plant growth from masonry joints on the east side of the porch.

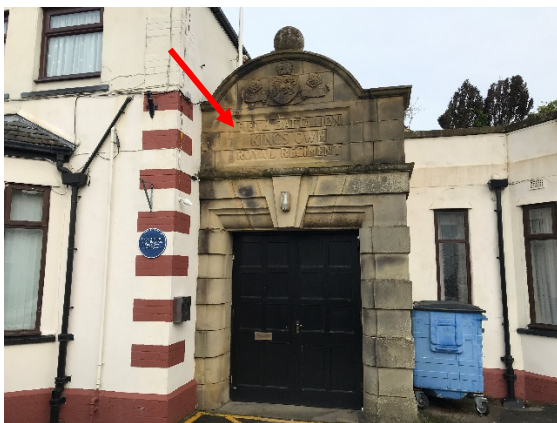
The sandstone main entrance porch façade. The inscription on the frieze is weathered on the left side. The weathering pattern is easy to read where there are fewer surface deposits (darkening) on the face of the stone.

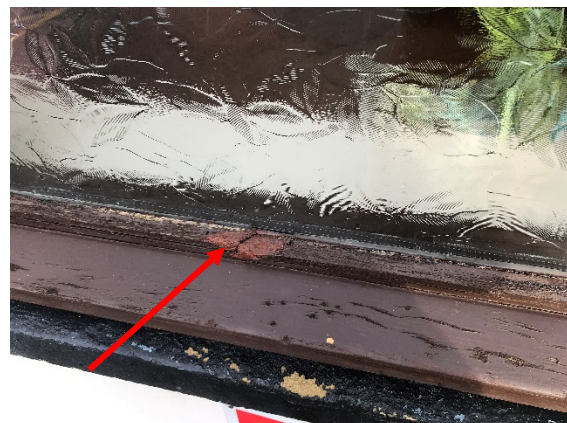
On several of the timber windows, the bottom external bead has decayed and should be replaced prior to any attempt at redecoration.

Decay in the glazing beads to several of the timber framed windows (front elevation bay window pictured)

Replace any decayed beads on the timber windows prior to redecoration. B7

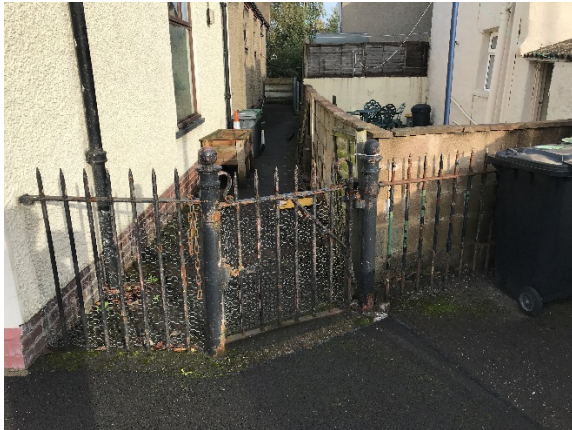
There is a section of iron railings with a single leaf gate on the east side of the drill hall, across the access path to the drill hall east fire escape door. The paintwork on the gate and railings has failed and needs to be redone to protect the metal from corrosion.

The iron gates to the east of the drill hall require redecoration to prevent corrosion of the metal.

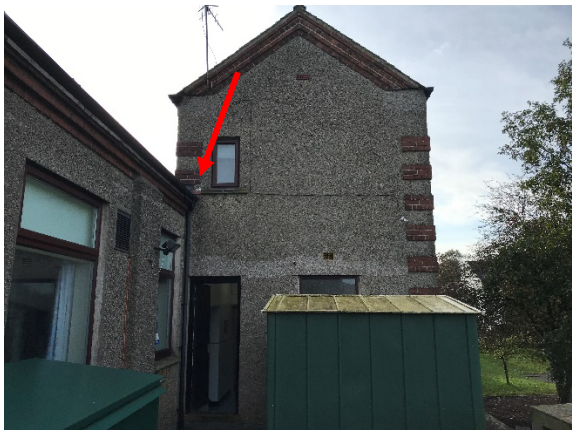
The north gable of the accommodation wing can be viewed from the flat roof over the northern part of the firing range. The gable is rendered with rough cast and repairs have been carried out above the door and window head. At the junction of the wall with the drill hall roof, the masonry has been pointed with sealant, presumably to prevent water ingress internally. It would be better if this was

removed, the joint re-pointed or the render repaired and the lead flashing over the flat valley gutter extended to the window sill.

The north gable of the accommodation wing, viewed from the flat roof. The masonry at the drill hall roof to wall abutment has been pointed up in sealant.

To the accommodation wing north gable, remove the sealant from the masonry joint and re-point or repair the render. Extend the lead flashing further over to the window sill. B5

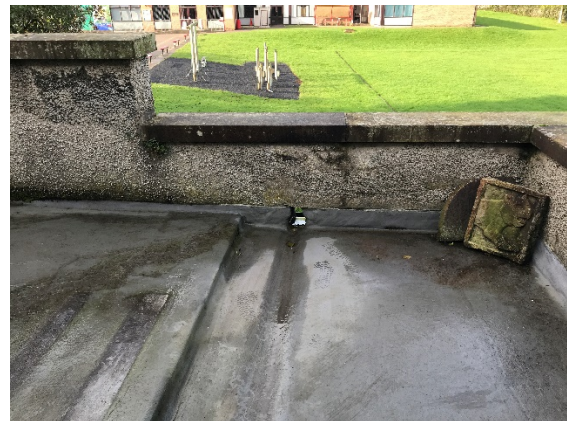
The parapet wall of the northwest flat roof is covered with roughcast render. In places, it is possible to see repair locations. Small plants were observed growing from the wall where the render appears to be cracked. The render coating on the outside face of the wall is cracked also and small sections have fallen off. There appears to be no lead DPC below the flat coping stones which will be a source of water penetration into the wall. Efflorescence on the internal face of the wall at lower ground floor level (in the shooting range) could be partly caused by water penetrating the flat roof wall head. It is recommended that the copings are lifted and re-bedded on a DPC.

Coping stones on the northwest flat roof are not bedded on DPC. The render on the wall face is cracked in places.

Repair the cracked render on the inner and outer face of the parapet wall. B6

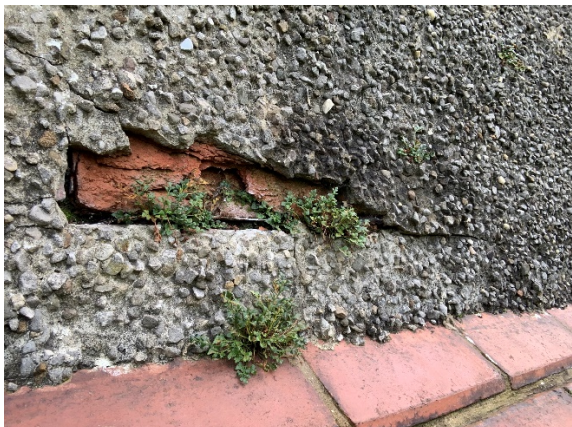
Render on the outer face of the northwest flat roof parapet wall is cracked and blown off in places.

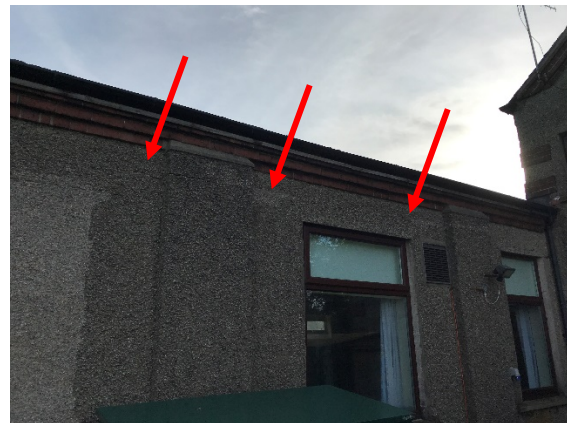
On the west wall of the drill hall, above the flat roof, the render has been patch repaired in places but fine cracking (2-5mm) is manifest through the render. It could be an outward rotation of the wall head, under load from the pitched roof structure where it is not restrained by the two-storey wing. Noted that cracking in the wall plaster is present on the interior face. An inspection by a structural engineer is required to determine the cause of the movement and to suggest a holding repair. The render can then be repaired.

Cracking along the wall head on the west elevation of the drill hall (from above the flat roof)

Appoint a structural engineer to inspect and report on movement at the head of the west wall of the drill hall (above the flat roof) where cracking through the external render and internal plaster is manifest. A1

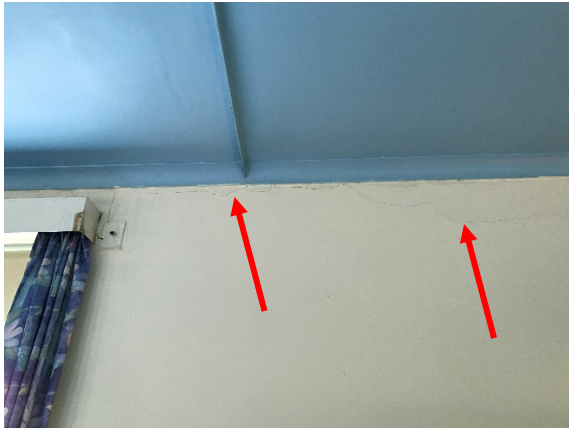
Cracking in the wall plaster at high level on the west side of the drill hall.

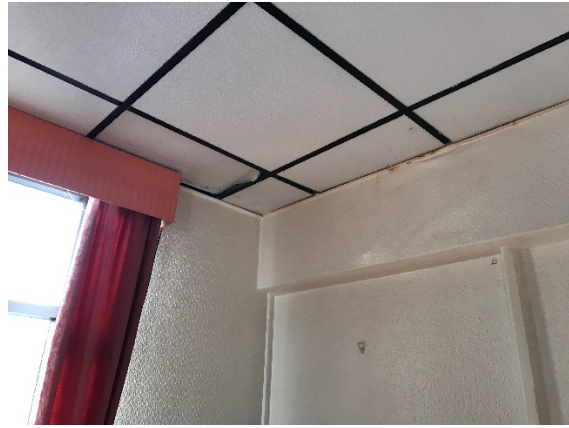
In the southwest corner, the ceiling tiles are stained and the grid bars are rusting. The wallpaper on the high-level walls is bubbling, all suggesting water ingress from above. The flat roof cover flashings, roof covering and wall upstands should be checked for integrity.

Water damage to high level wall finishes and ceiling in the southeast meeting room.

Inspect flat roof above southeast meeting room to determine cause of water ingress leading to damage to internal finishes. B12

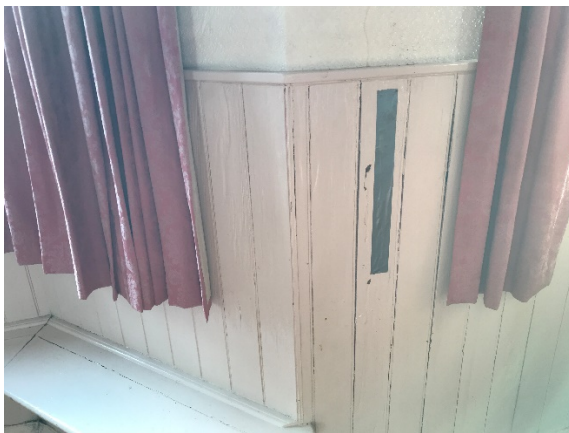
Noted that the wall panelling on the south wall, below and adjacent to the windows, is decayed. The timber is quite friable. There is no ventilation gap between the panelling and the masonry wall.

The timber wall panelling on the south wall of the southeast meeting is decayed. Sections require replacement.

Remove the decayed wall panelling on the south wall of the southeast meeting room and replace with new. B11

Consider removing all of the wall panelling in the southeast meeting room and re-fixing it, set slightly off the wall with a slot vent top and bottom to promote air movement behind the panelling and reduce the risk of timber decay. D4

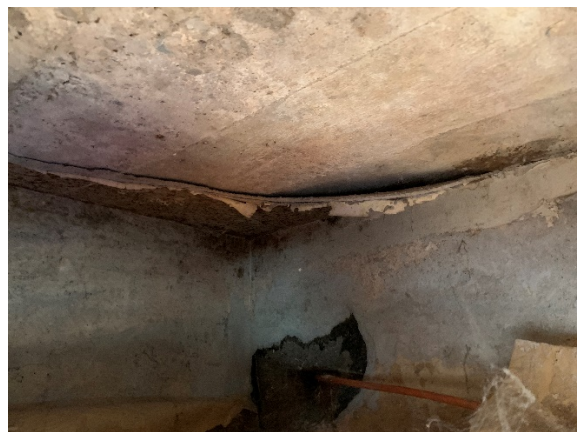
In the ceiling void above the southeast office looking to the southwest corner, where water damage is evident on the ceiling grid and wall finishes below.
